# Structural Condition Assessment of Acme Power Plant

Acme, Wyoming

July 24, 2023

Ayres Project No. 51-0672.00

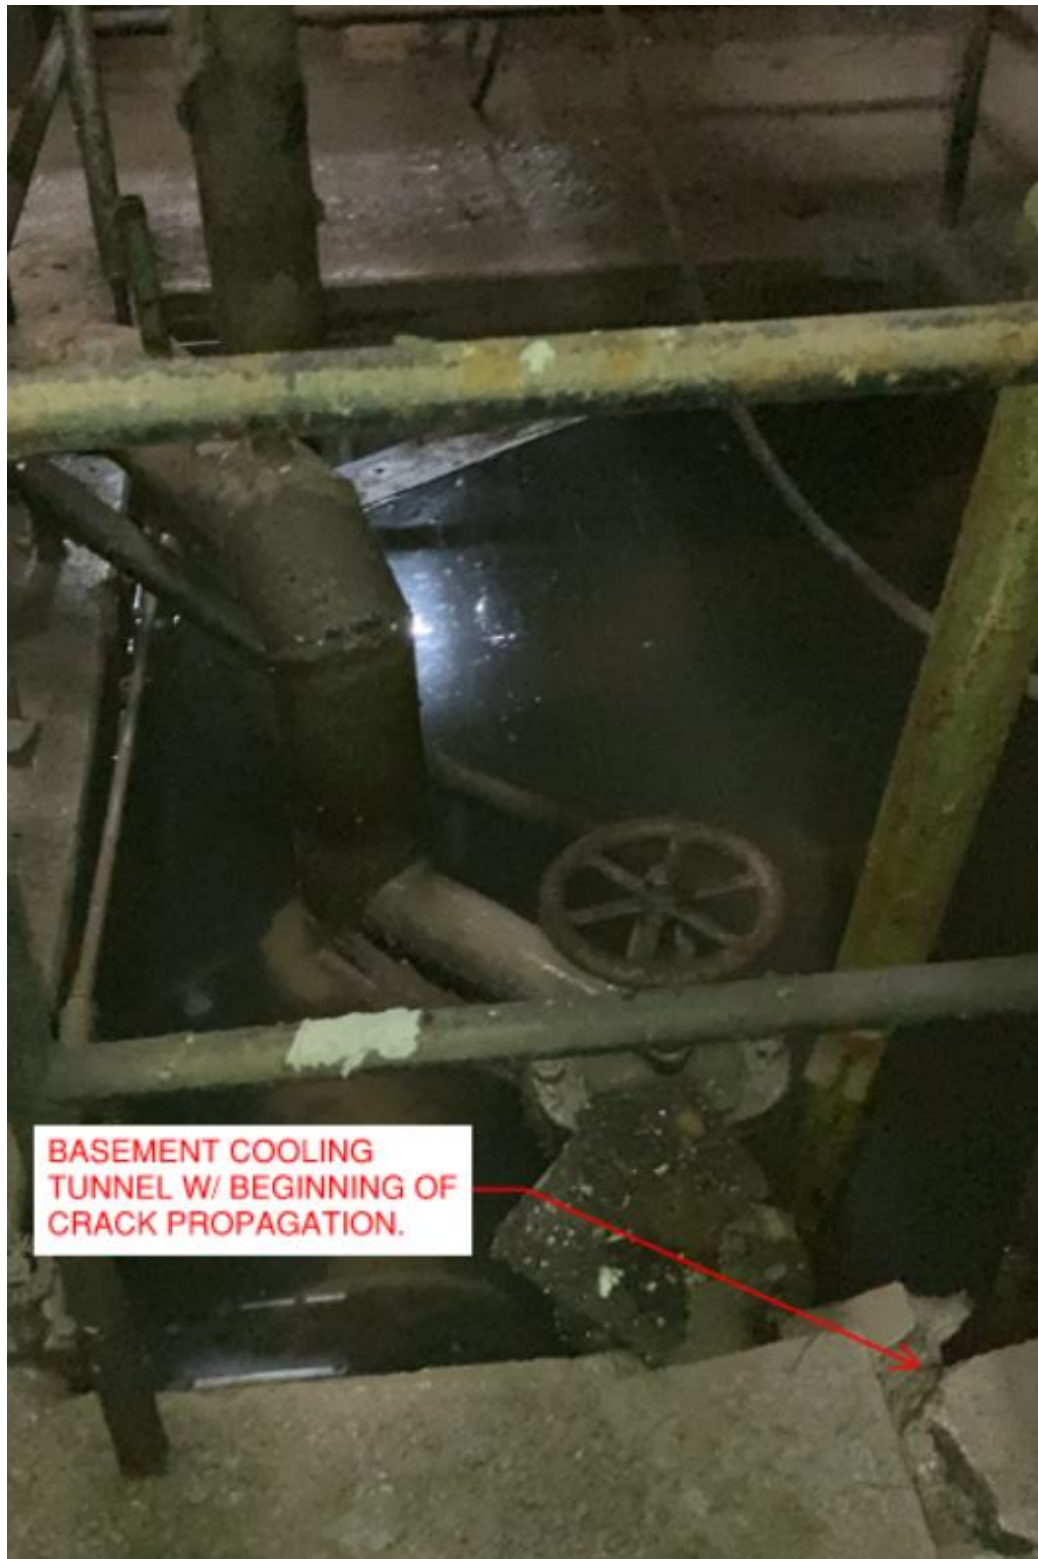
Figure 1

The basement floor of the 1910 power plant was limitedly observed due to a significant sedimentation accumulation/buildup throughout the top of concrete floor. The floor showed visible signs of new structural degradation at the cooling tunnel where it appears rising water levels may have created a hydrostatic uplift surcharge exceeding the capacity of the structural slab. The crack appears to occur along a construction and/or control joint above the tunnel and propagates along the joint to the other tunnel opening and slab penetration. (See Figures 1-2 in Appendix A)

The overall condition of the basement structural slab was observed to range from unknown to satisfactory to poor due to the presence of isolated areas of slab cracking. Safety recommendations include partitioning/roping off areas where the slab is not supported directly on grade and cracking is observed above or near openings and tunnels. Where unknown conditions of the floor slab exist, those areas

should be pressure washed/cleaned as deemed appropriate given the presence of asbestos contaminants to remove the accumulated sediment and exposed the top of slab for visible inspection so other areas of potential concern may be identified and partitioned as required for worker safety.

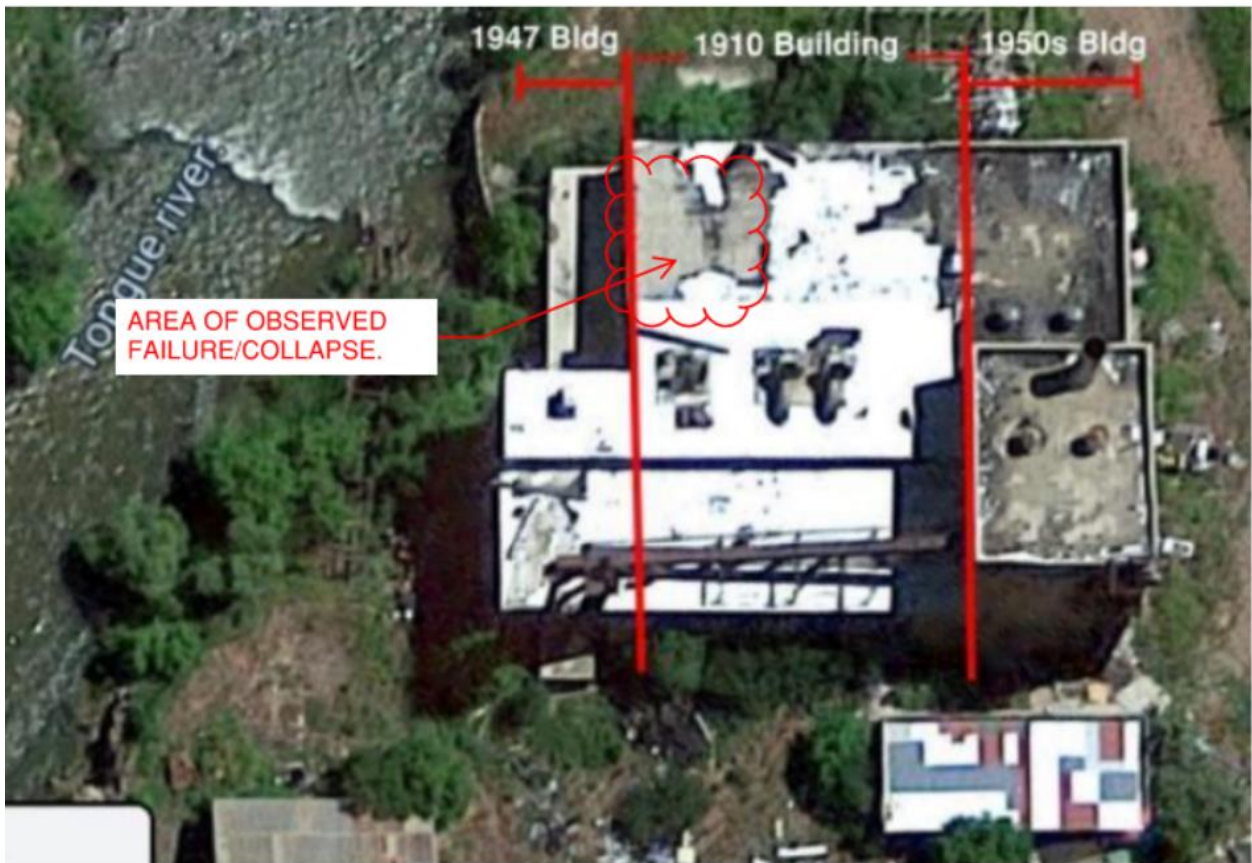
Figure 3

The roof of the 1910 power plant was documented in the 2020 AET report to be in poor condition in select areas. It was initially recommended that the original roof would require a combination of repair and replacement. In the time elapsed between the 2020 AET assessment and this follow up condition assessment, large portions of the cast in place concrete roof slab have experienced catastrophic structural failure/collapse. Further observation has revealed failure mechanisms which make the original roof in its entirety an unsafe area for construction workers due to the high likelihood of crack and failure propagation even at areas which show limited signs of structural degradation. In addition, without the top of wall bracing provided by the roof diaphragm in the failed area, the top of brick wall could be viewed as only partially braced by the existing steel purlins. While failure of the wall isn’t expected, isolated disconnected bricks pose the risk of failing from the top of wall. (Figure 3-7)

The current overall condition of the original 1910 roof structural slab was observed to be in serious condition due to the failure of large areas of the cast in place concrete roof and the life safety hazard posed by failing large concrete/masonry debris with potential construction workers present below. Safety recommendations include providing horizontally placed heavy duty construction debris drop netting complying with OSHA regulations and conforming to ANSI A10.37 standards. It is recommended that the drop netting be installed as high as possible to reduce the force from potential failing debris. It is recommended drop net anchorage be placed at existing steel purlin locations and at steel girder locations where the purlins bear. Where the netting needs to anchor/connect to the existing clay masonry walls, it is recommended that thru-eye bolted connections with square plate washers be used to adequately anchor the netting to the clay brick walls. Pressure treated 2x members of sufficient length/width could also be used in lieu of steel plate washers to engage more brick and limit anchorage pull-out. (Figure 8) Ayres has not performed a structural analysis regarding the capacity of the existing structural members as they pertain to the required debris protection system nor the required debris protection connection types and spacing. The required debris fall protection system and associated connections are considered means and methods to be established by the General Contractor.
