REPORT OF STRUCTURAL EVALUATION

AET Project No. 19-20035

ACME POWER PLANT – STRUCTURAL
EVALUATION
ACME, WYOMING

OCTOBER 11, 2020

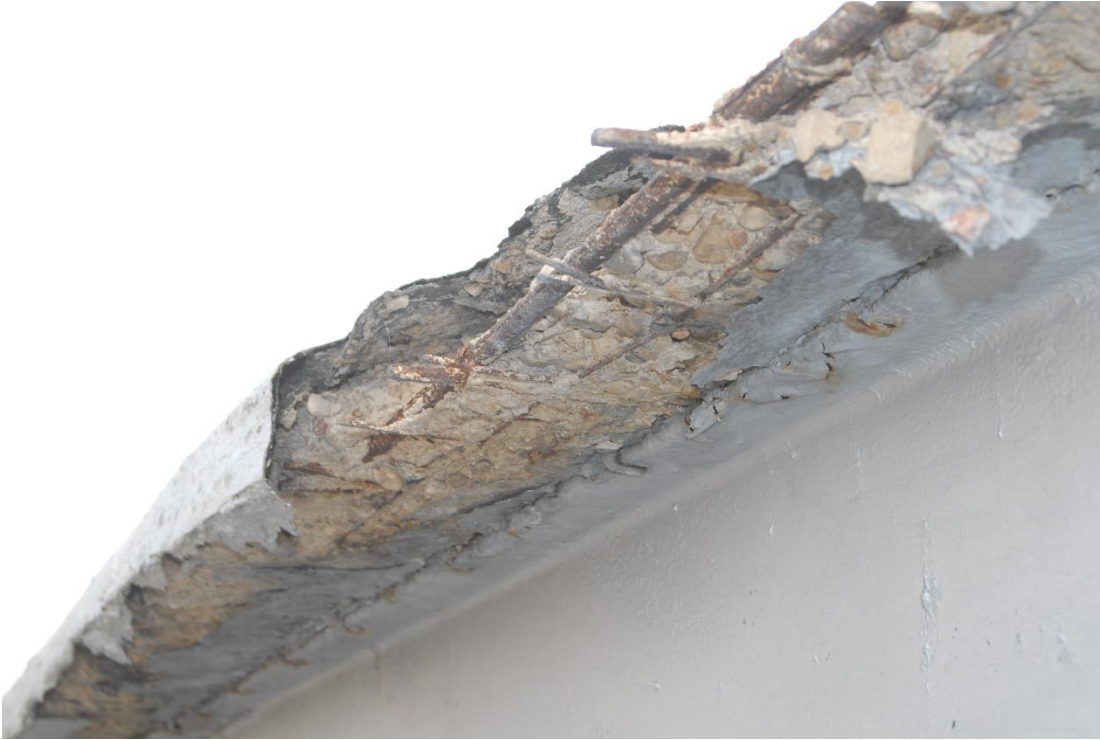
The roofs of this structure are in fair to poor condition: daylight is visible through the roof above the generator room, and the edges of the clerestory roof are severely worn. These roofs will require a combination of repair and replacement. See photos 29 & 30.

Photo 30: Deteriorated roof edge of 1910 clerestory roof – concrete has fallen away, leaving only reinforcing bars.

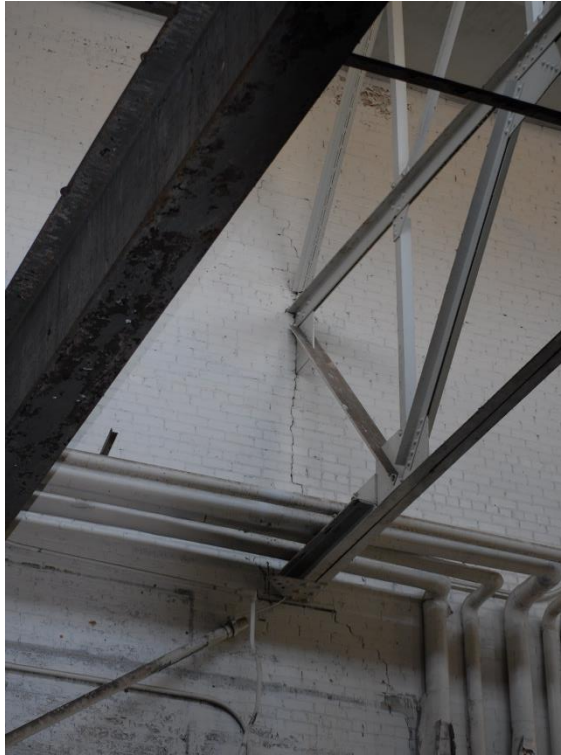
The center brick wall is in generally good condition. There are cracks in the brick where the large roof trusses intersect it; these will require repair. Otherwise, the wall, including the pilasters against its east face, should not require significant repairs. See photos 31 & 32.

Photo 32: Close-up of wall crack at truss.

Recommendation 5: The north/south spanning brick center wall of the 1910 building is cracked between the roof truss top and bottom chords - at four roof trusses. This requires a structural evaluation to determine if the bricks are overstressed in compression; it may require some brick reconstruction within this small area.

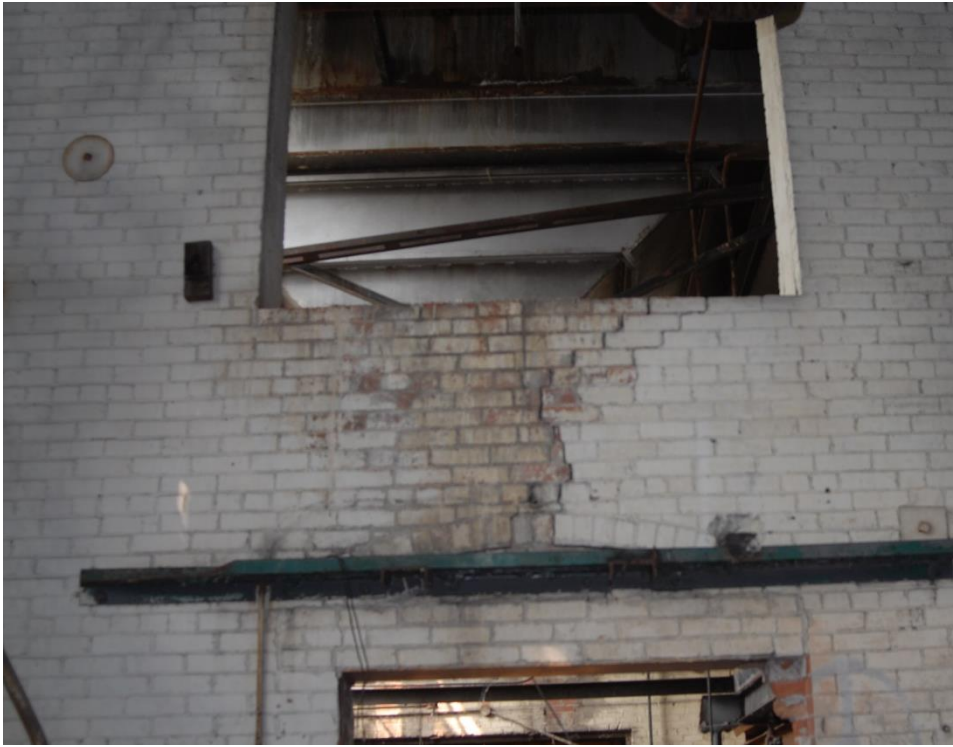
There are significant cracks and evidence of building movement in the original north and south walls of the 1910 building, where window openings were expanded to doorways; these areas require repair and some resetting of bricks. See photos 33 – 35.

Photo 34: Crack in wall between 1950s and 1910 generator room, above doorway at east end of wall.

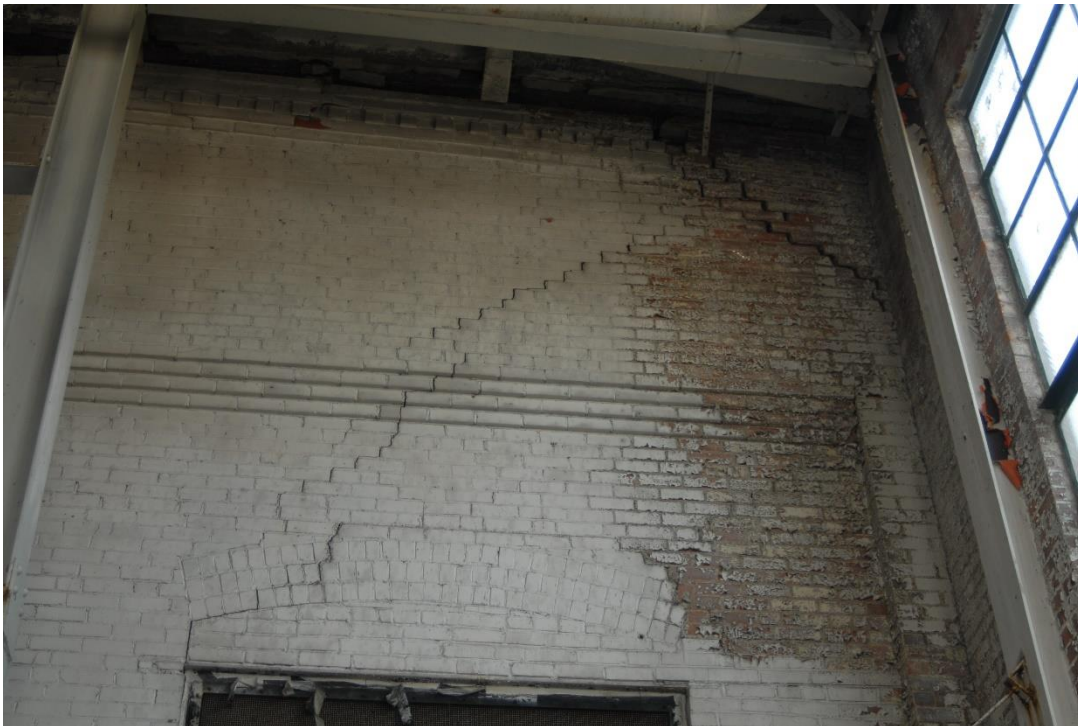
Photo 35: Crack in north wall of 1910 building, at east end, above mezzanine.

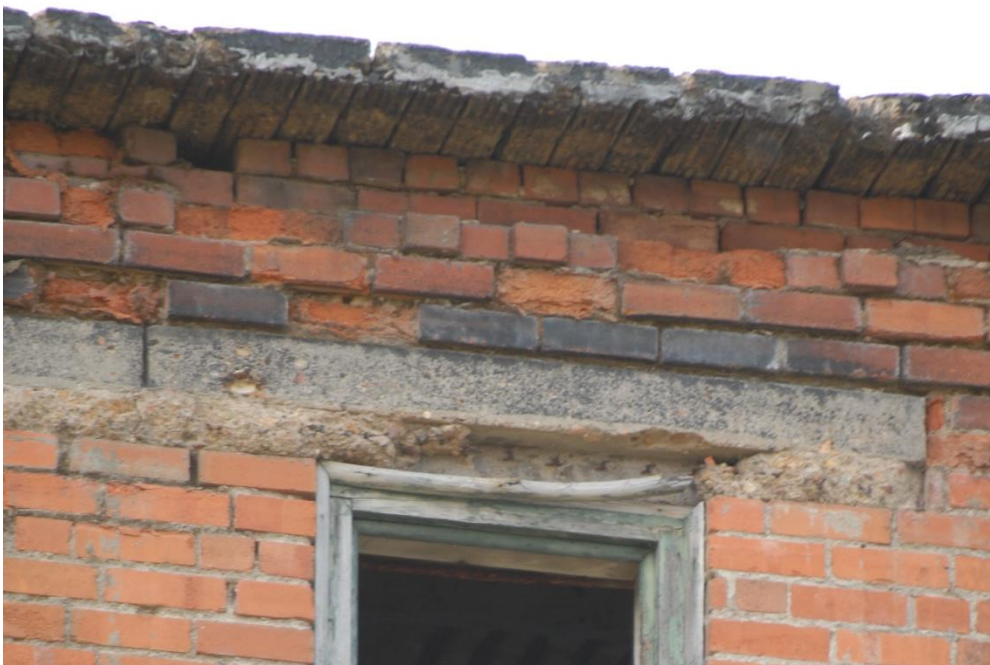
Photo 37: Damage to top five feet of 1910 building.

Recommendation 6: The exterior brick walls of the 1910 building and 1947 addition require repair and some reconstruction. The top five feet require 100% repointing and approximately 40% reconstruction. The decorative corbelling and dentils at the top of the walls require complete reconstruction, with 50% brick replacement. The walls below the large window heads require spot repointing – approximately 50% requires attention, with 10% requiring resetting or replacement.

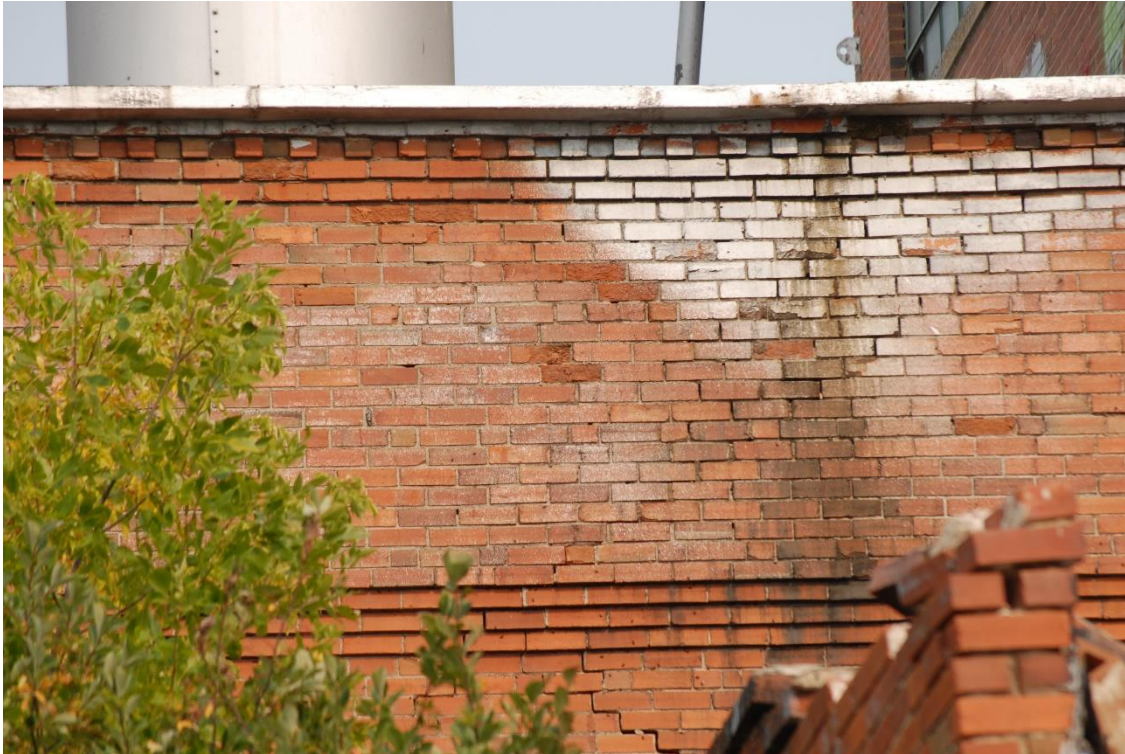
Photo 38: Brick condition at lower half of 1910 building exterior wall.

These walls should be spot repointed, with approximately 50% of the mortar joints needing attention and 10% of the bricks requiring resetting or replacement.

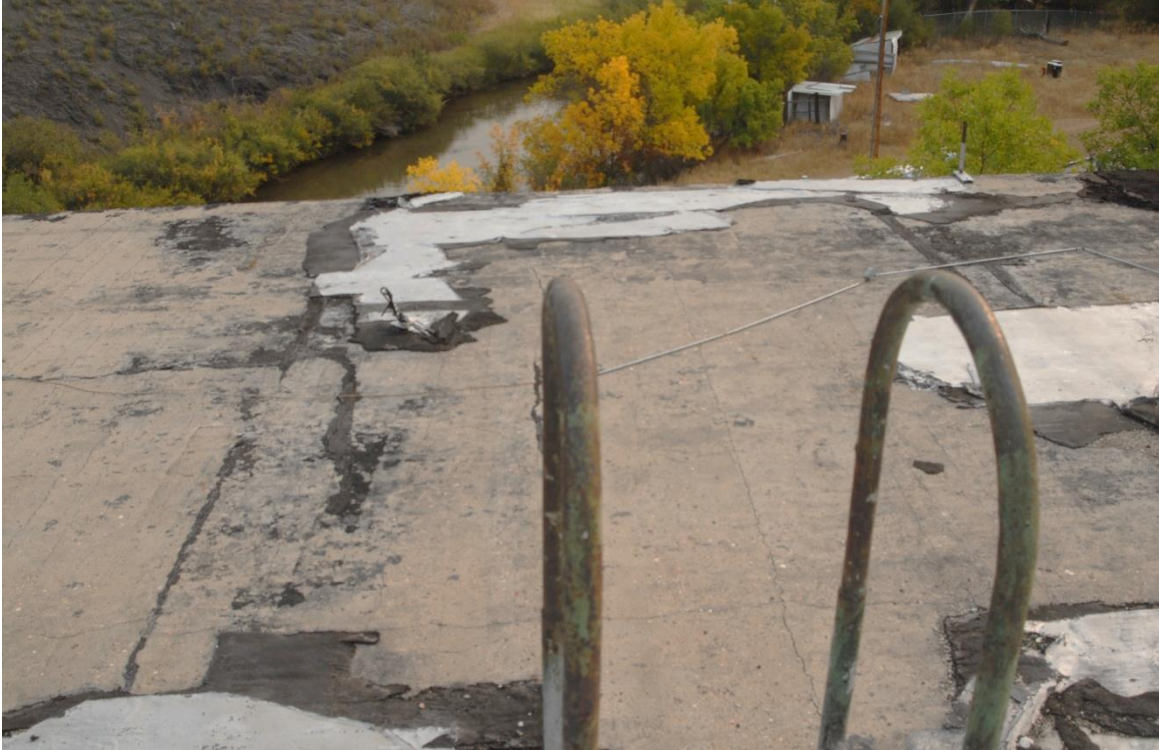
- The roofing membrane requires replacement over the office and over the boiler room.
- The structural roof decks above the office and the boiler room require additional evaluation to determine their retained capacity. There is a fibrous material with wire mesh attached to the underside of the clerestory roof that may be an asbestos layer, or it could possibly be an early proprietary deck that is part of the structural system. The clerestory roof slab edge is deteriorating and needs to be cut back and replaced. The percentages of repair and replacement of the clerestory roof are expected to be similar to the 1910 roof.

Photo 40: Worn, patched and damaged roof over office of 1947 addition.

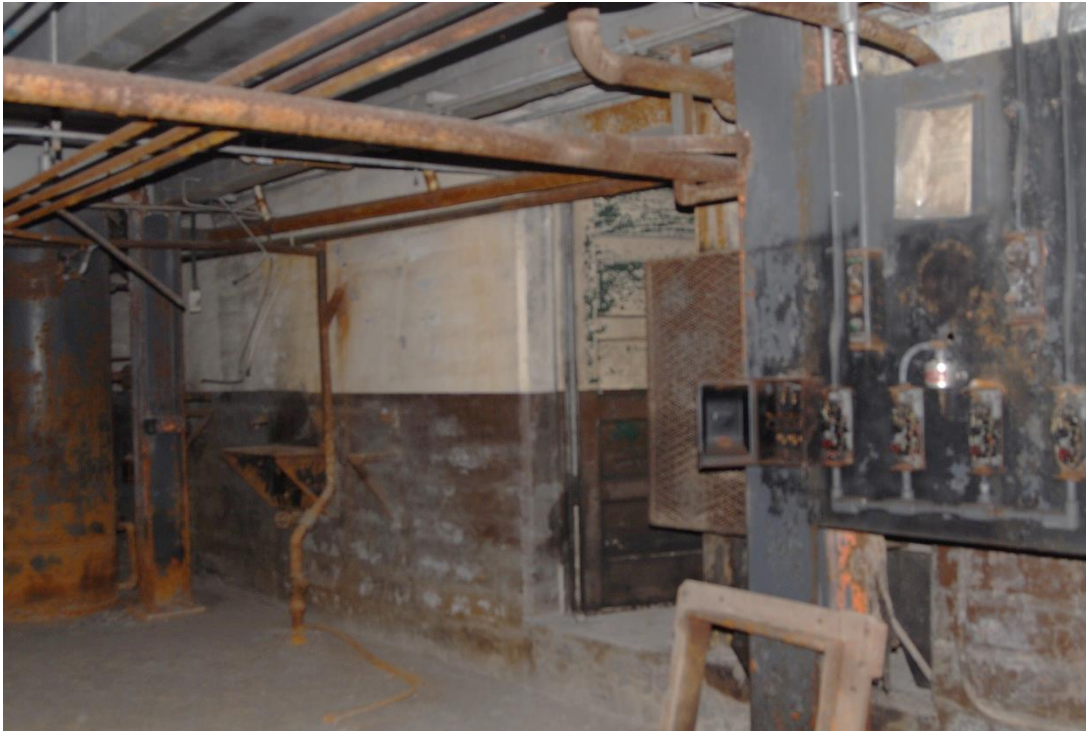
- There is little visible deterioration of the concrete basement or steel and concrete first floor. The steel columns in the basement have surface rust that should be removed and recoated; the current deterioration has not reduced its strength.

Photo 44: Column in 1950s basement, showing surface rust.

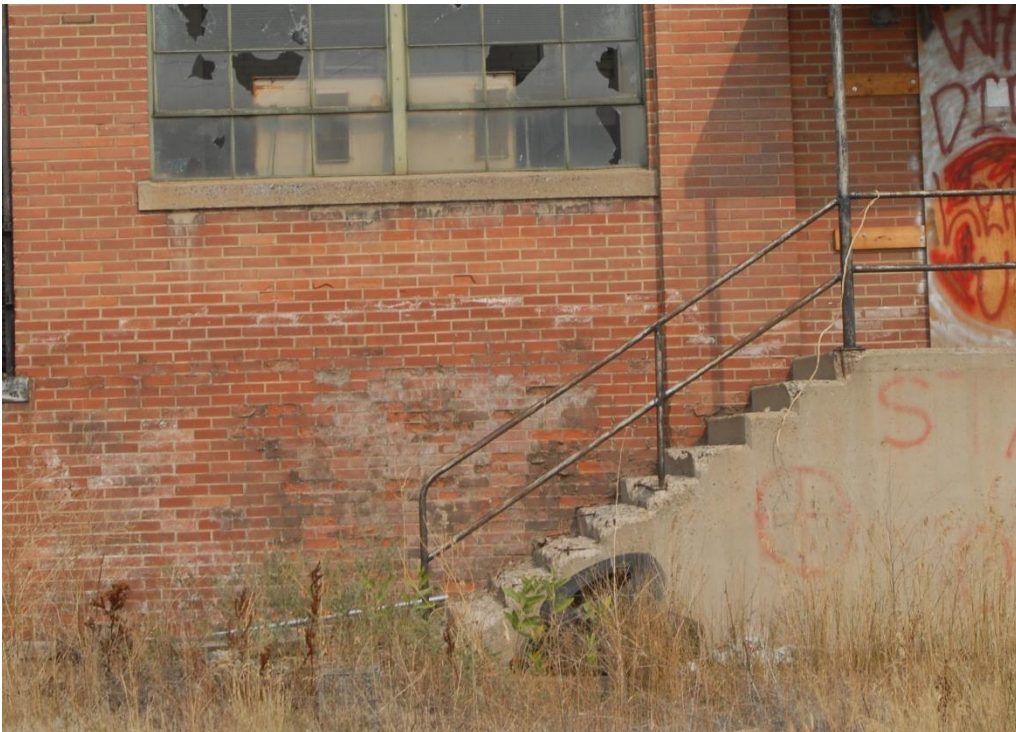
Photo 47: Close-up of damaged stair treads at south face of 1950s addition.

- Concrete exterior stairs are badly spalled and require selective demolition of the treads and landing, and replacement concrete.
- The exterior brick cladding will require selective repointing to address the east face deterioration, and localized damage in other areas. The percentage of wall area that requires repointing is less than 20%.
