PHASE II ENVIRONMENTAL SITE ASSESSMENT FOR ACME POWER PLANT HAZARDOUS BUILDING MATERIALS 165 ACME ROAD SHERIDAN, SHERIDAN COUNTY, WYOMING

October 2017
0003/1609-07
W0411.1A.01334
EP-S8-13-01
Bill Rothenmeyer

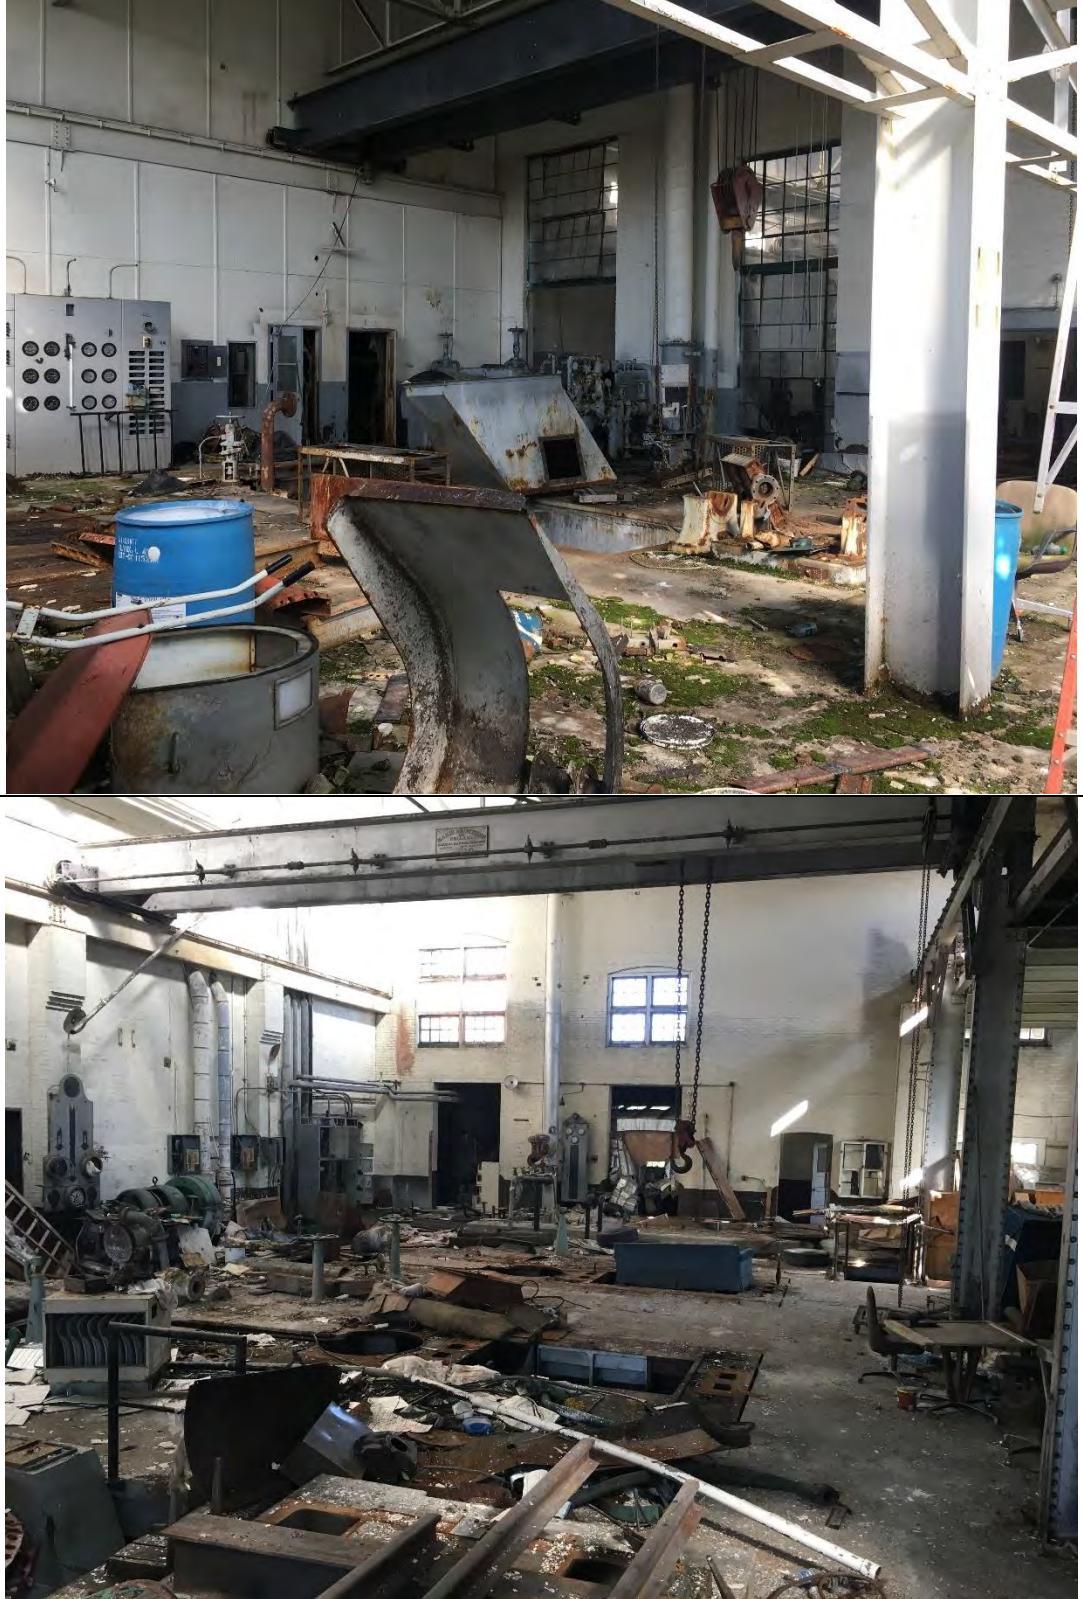
Photo 3	No.	Date: 06/01/2017	
Phot	o Co	ordinates	
Lat	4	4.895706	
Long	-1	06.985367	
Directi Taken: 289	on P 	hoto 24120603	1
Descri	ptior	n:	
Turbine to the S Unit. Fi confirm and fire wall we be AC	e rooi Stean berb ned to e doo ere as M.	m adjacent n Boiler oard was o be ACM rs on that ssumed to	
Photo 4	No.	Date: 06/01/2017	
Phot	o Co	ordinates	
Lat	4	4.912767	
Long	-106.987853		
Long	-1	06.987853

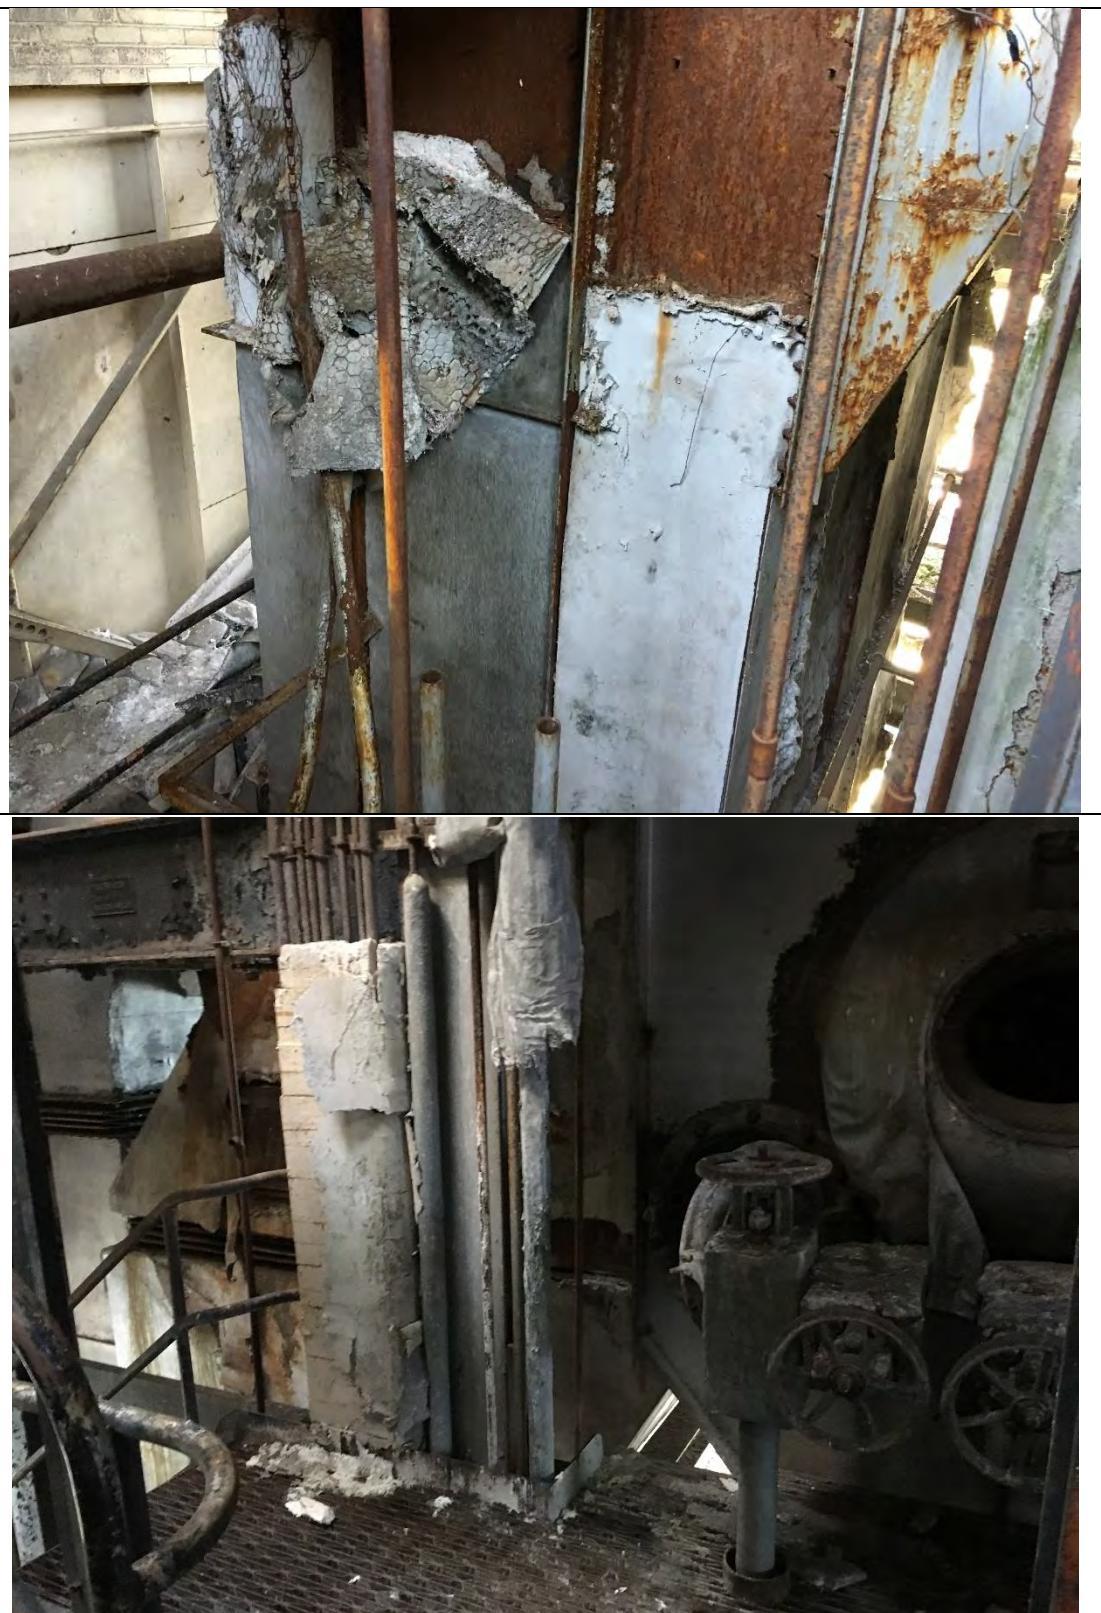
Photo 7	No.	Date: 06/03/2017			
Phot	o Co	ordinates			
Lat	4	4.912783			
Long	-1	06.988092			
Directi Taken 291	on P : .1017:	hoto 54385965			
Descri	ption):			
ACM b lath on Boiler I	ACM boiler jacket and lath on the Steam Boiler Unit.				
Photo 8	No.	Date: 06/04/2017			
Phot	o Co	ordinates			
Lat	4	4.912778			
Long	-1	06.988014			
Long -106.988014 Direction Photo Taken: 110.776327241079 Description: ACM fire brick and pipe insulation by the Steam Boiler Unit.

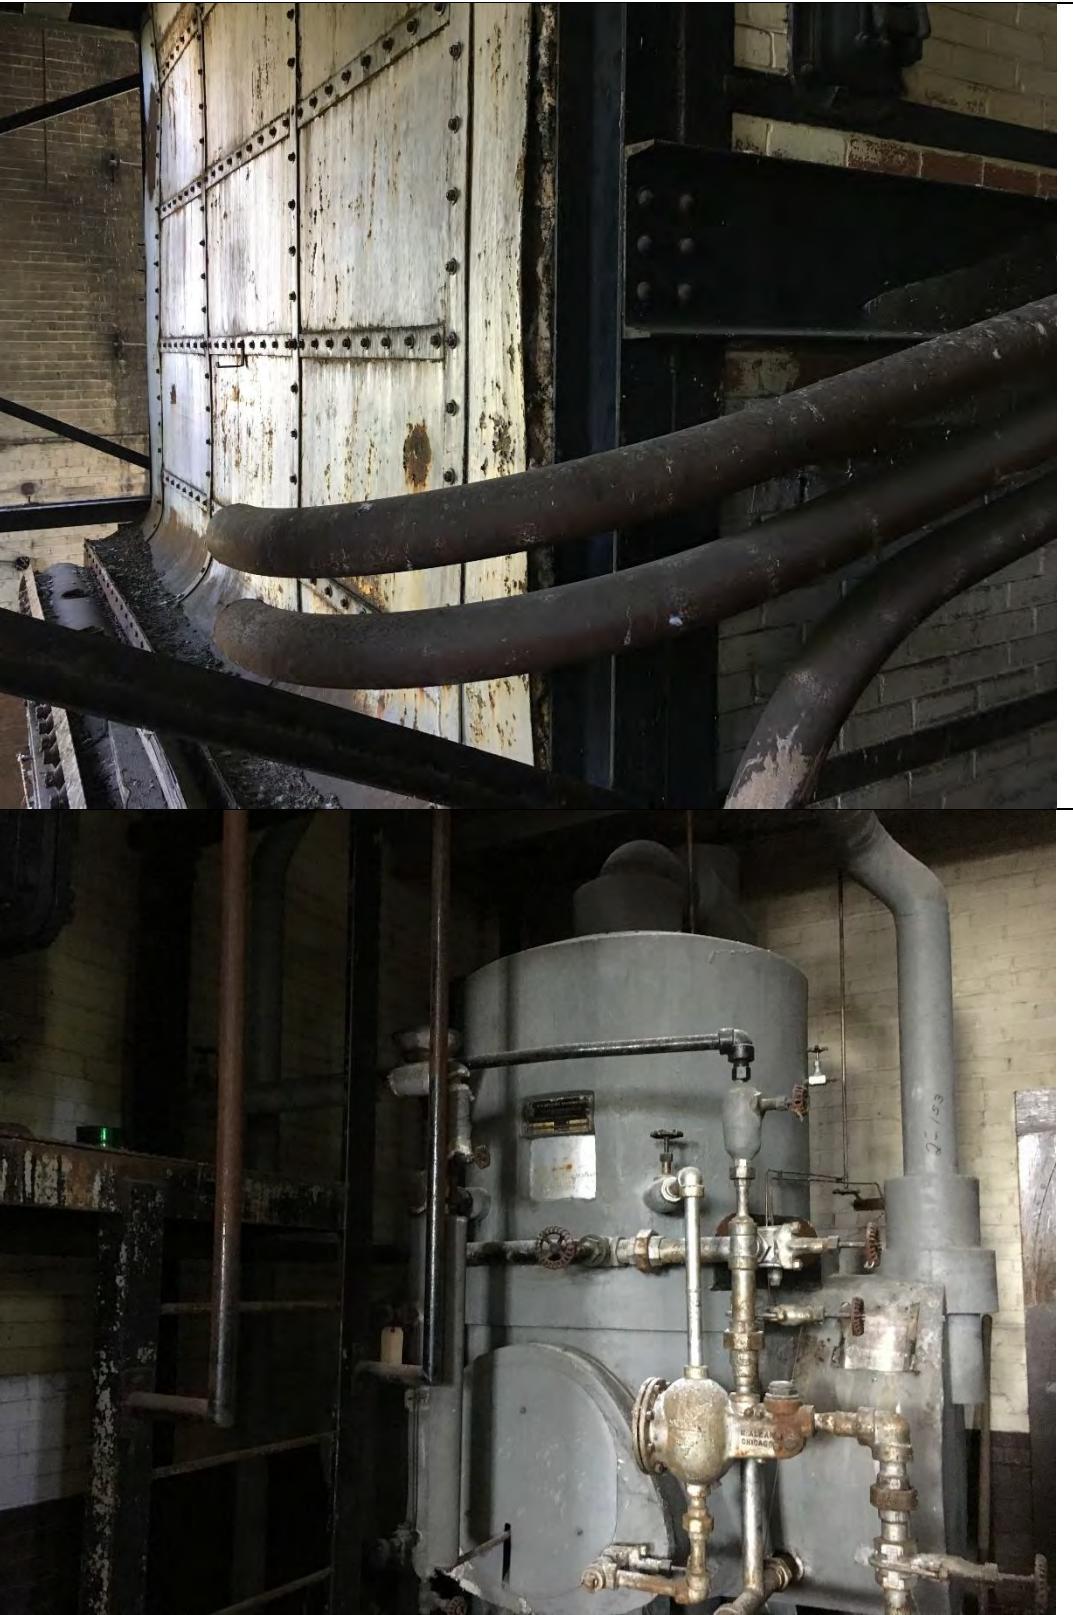
Photo 19	No.	Date: 06/04/2017	
Phot	to Co	ordinates	
Lat	4	4.913014	
Long	-1	06.988303	
Direct Taken 334	ion P : .98324	hoto 40223464	
Descr	iptior	1:	
ACM b on the	ooiler Detro	insulation bit Stoker.	
Photo 20	No.	Date:	Ę
Phot		ordinates	
Lat		4 012059	
	4	06 088002	
Long	-1	00.900092	
Direct Taken 301	ion P : .0658	hoto 43621399	
Descr	iptior):	
Evapo with A runs, a	rator l CM pi and ja	by the office pe joints, cket.

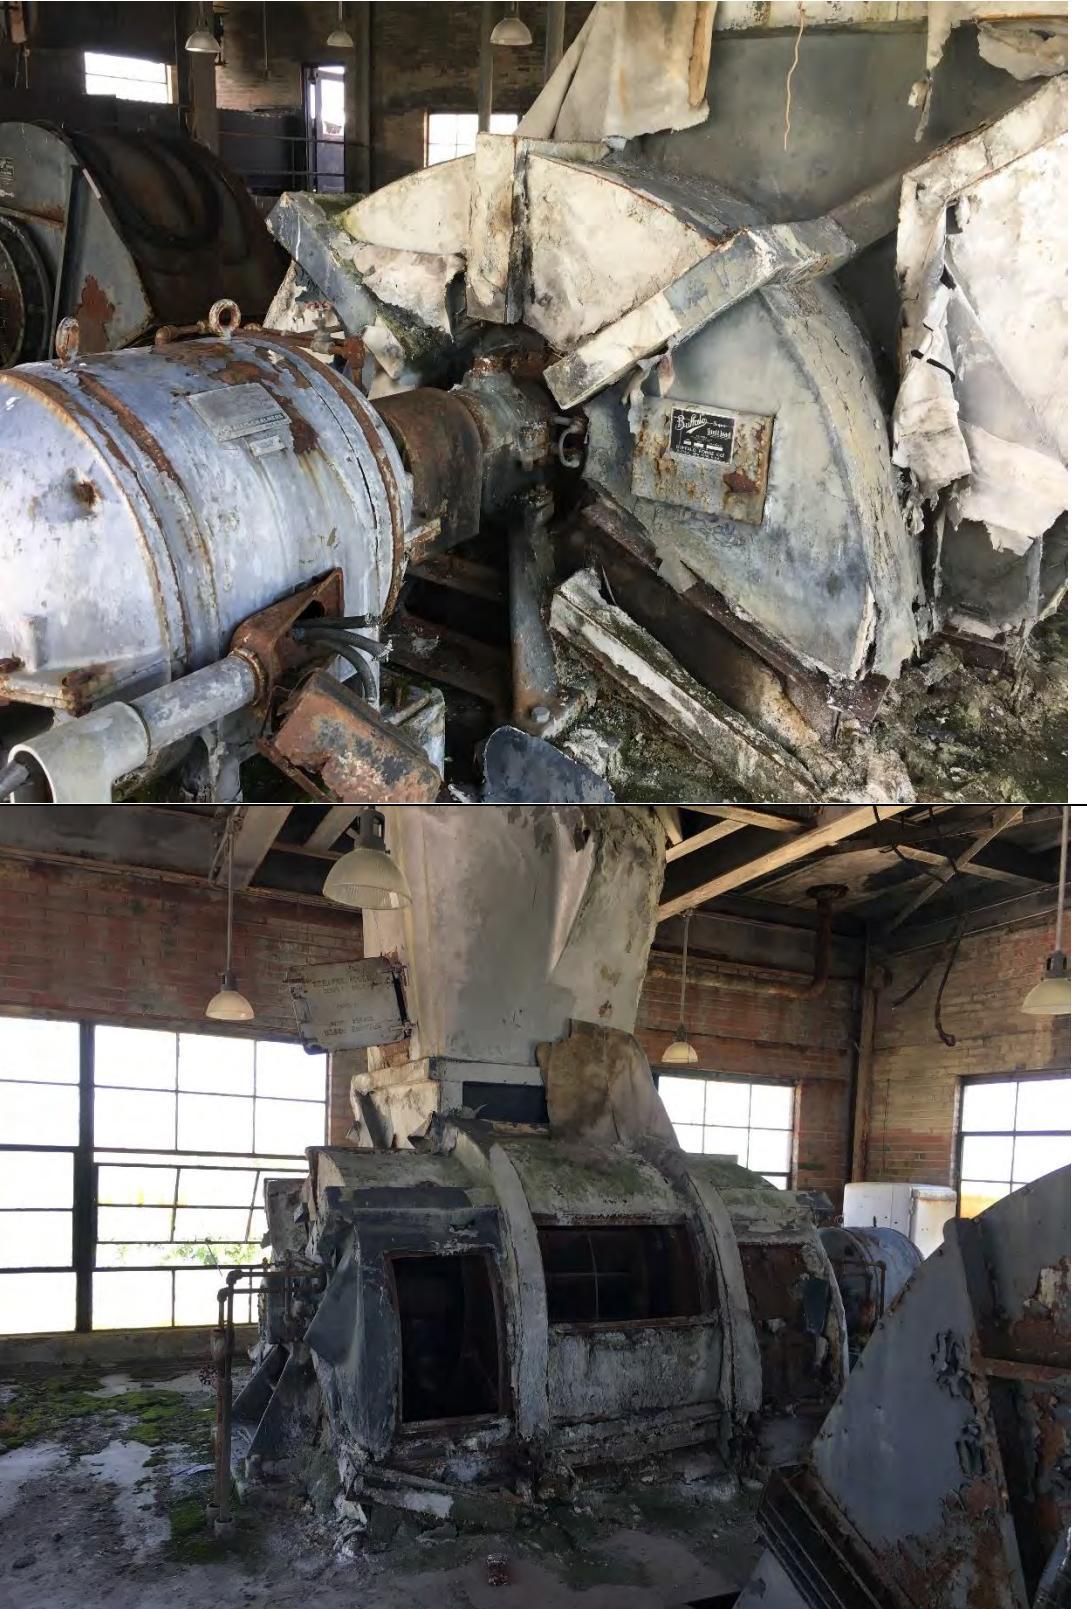
Photo 21	No.	Date: 06/01/2017	
Phot	o Co	ordinates	- FL
Lat	4	4.912461	
Long	-1	06.987878	1
Directi Taken 2.57	ion P : 71594:	hoto 20289855	
Descri	iptior	ı:	
ACM was sa out of t motor	vire in ample the in by the	esulation d coming duction blower.	
Photo 22 Phot	No. 2 to Co	Date: 06/03/2017 ordinates	
Lat	4	4.912022	
Long	-1	06.987244	
Directi Taken 32.0	ion P : 08331:	hoto 29733692	
ACM ja blower catwall	acket fan c k.	on the on the upper	
			Concernance of

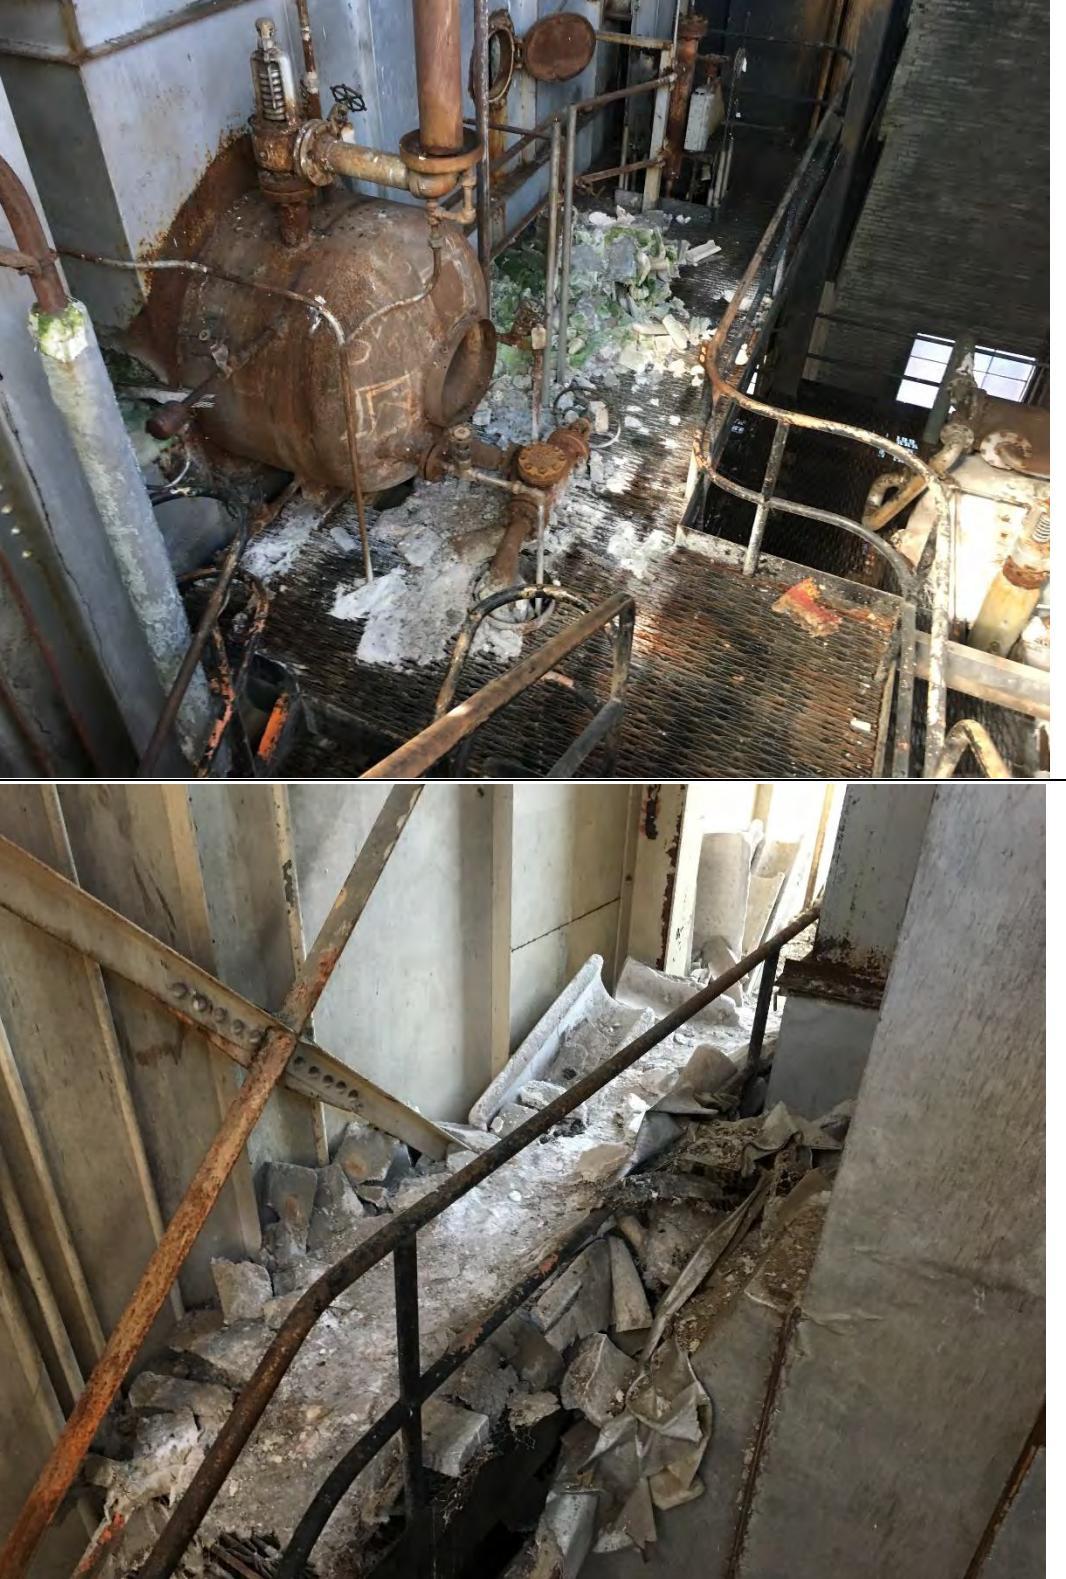
Photo 27	No.	Date: 06/04/2017	
Phot	o Co	ordinates	
Lat	4	4.912808	
Long	-1	06.988092	
Directi Taken: 199.	on P	hoto 94520548	
Descri ACM in on a ca Steam	ptior Isulat Itwall Boile	n: tion debris t by the tr Unit.	
Photo 28	No.	Date: 06/04/2017	
Phot	o Co	ordinates	
Lat	4	4.912803	
Long	-1	06.988092	ALC: NO
Directi Taken: 101.	on P 4022	hoto 55639098	
ACM in on a ca Steam	nsulat Itwall Boile	tion debris the the tr Unit.

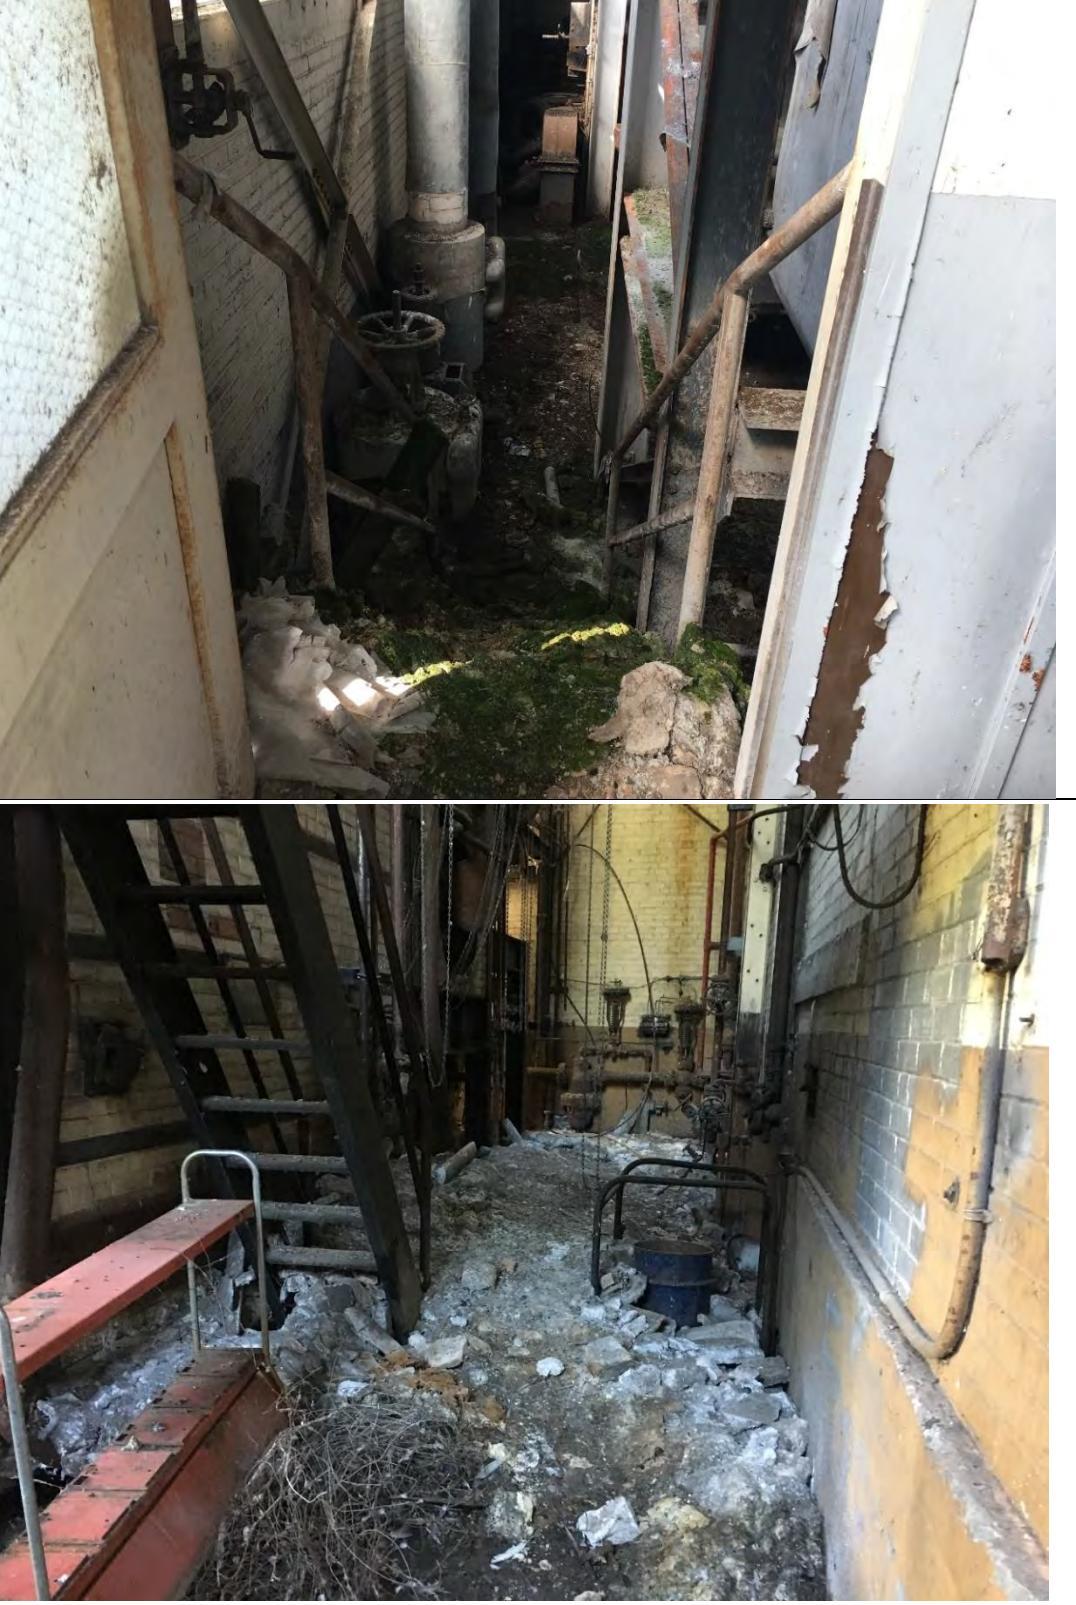
Photo 31	No.	Date: 06/04/2017	
Phot	o Co	ordinates	
Lat	4	4.912778	
Long	-1	06.987878	1
Directi Taken 193	on P : .3275	hoto 26132404	
Descri	ptior):	HAR
ACM ir in the a Steam	nsulat area b Boile	tion debris by the tr Unit.	
Photo 32	No.	Date: 06/04/2017	
Phot	o Co	ordinates	
Lat	4	4.912972	and the second
Long	-1	06.988319	
Directi Taken 4.71	on P : 6064	hoto 75716065	
Descri	ptior):	
ACM ir presen adjace Stoker	nsulat t in a nt to t	ion debris hallway the Detroit

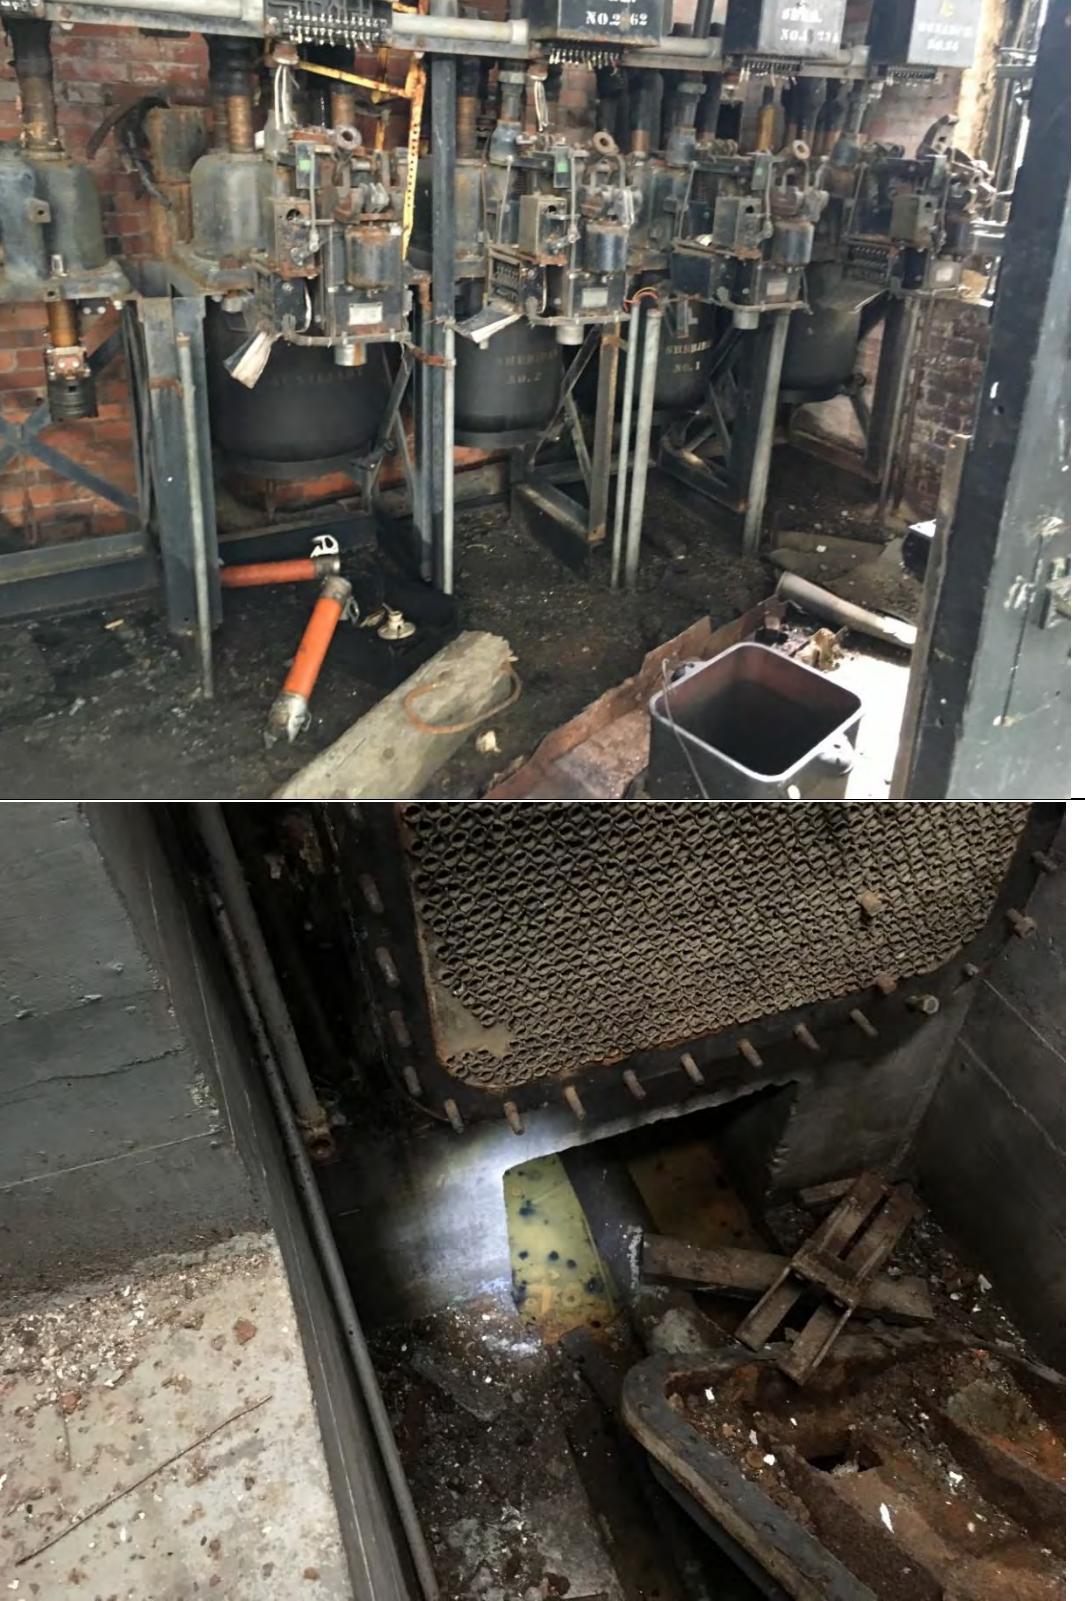
Photo N	o .	Date:	and a state of the
35		06/04/2017	1 STATE
Photo	Со	ordinates	1020
Lat	4	4.912808	1 × 1 ×
Long	-1	06.987939	1 1
Directio Taken: 46.16	n P 949	hoto 15254237	11
Descrip	tior	ו:	
PCB trai PCB cor sedimen below.	nsfc htan ts a	ormers with ninated and concrete	
Photo N 36	o .	Date: 06/04/2017	
Photo	Со	ordinates	11
Lat	4	4.912967	1
Long	-1	06.987953	
Directio Taken: 80.51	n P 699 [°]	hoto 71671388	
Descrip	tior	ו:	
Mold obs basemen plant.	serv	ved in the f the power

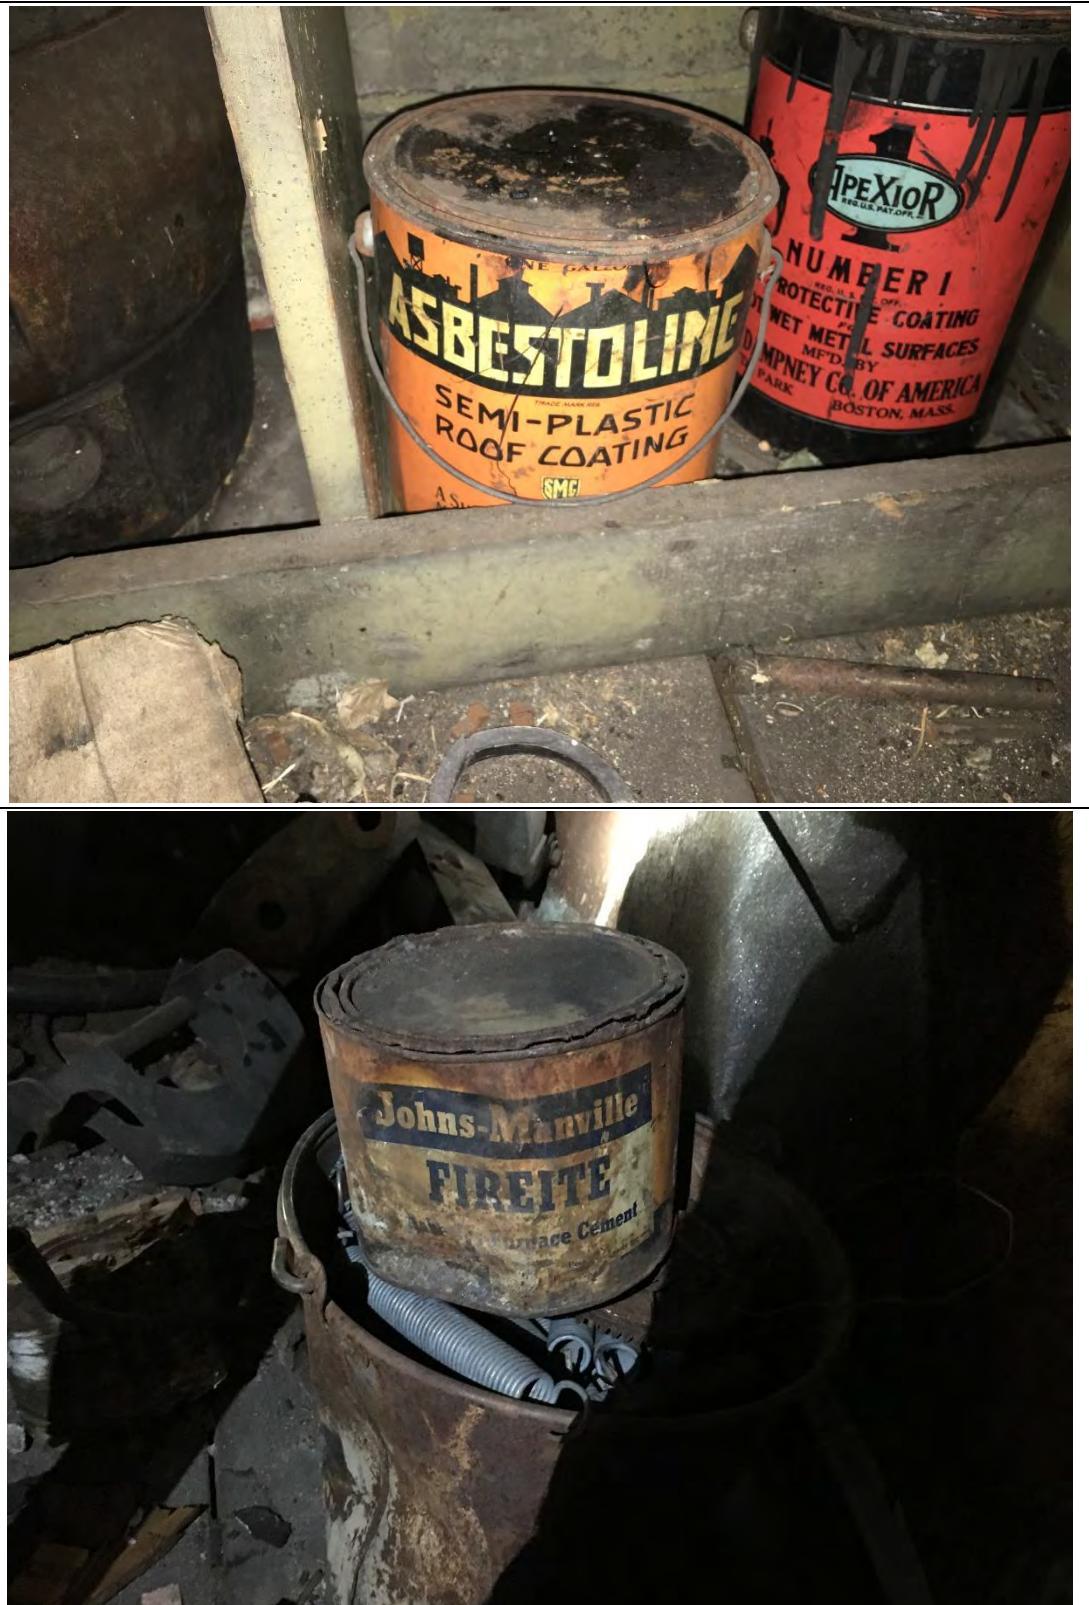
Photo 46 Phot Lat Long Direct Taken 273 Descri Partial Johns- Asbest Cemer the loft furnace power to be A	No. o Co 4 -1 ion P : .1550 iption conta Many tos Fu nt also : of the plant CM.	Date: 05/31/2017 ordinates 4.912669 06.988053 hoto 80213904 1: ainer of ville Fireite urnace o found in e shop. All nent in the is assumed
