# Former Acme Power Plant Infrastructure Needs Assessment Technical Assistance Grant

**Prepared for  
Sheridan County Conservation District**

**Prepared by:** WWC Engineering  
1849 Terra Avenue  
Sheridan, WY 82801  
307-672-0761

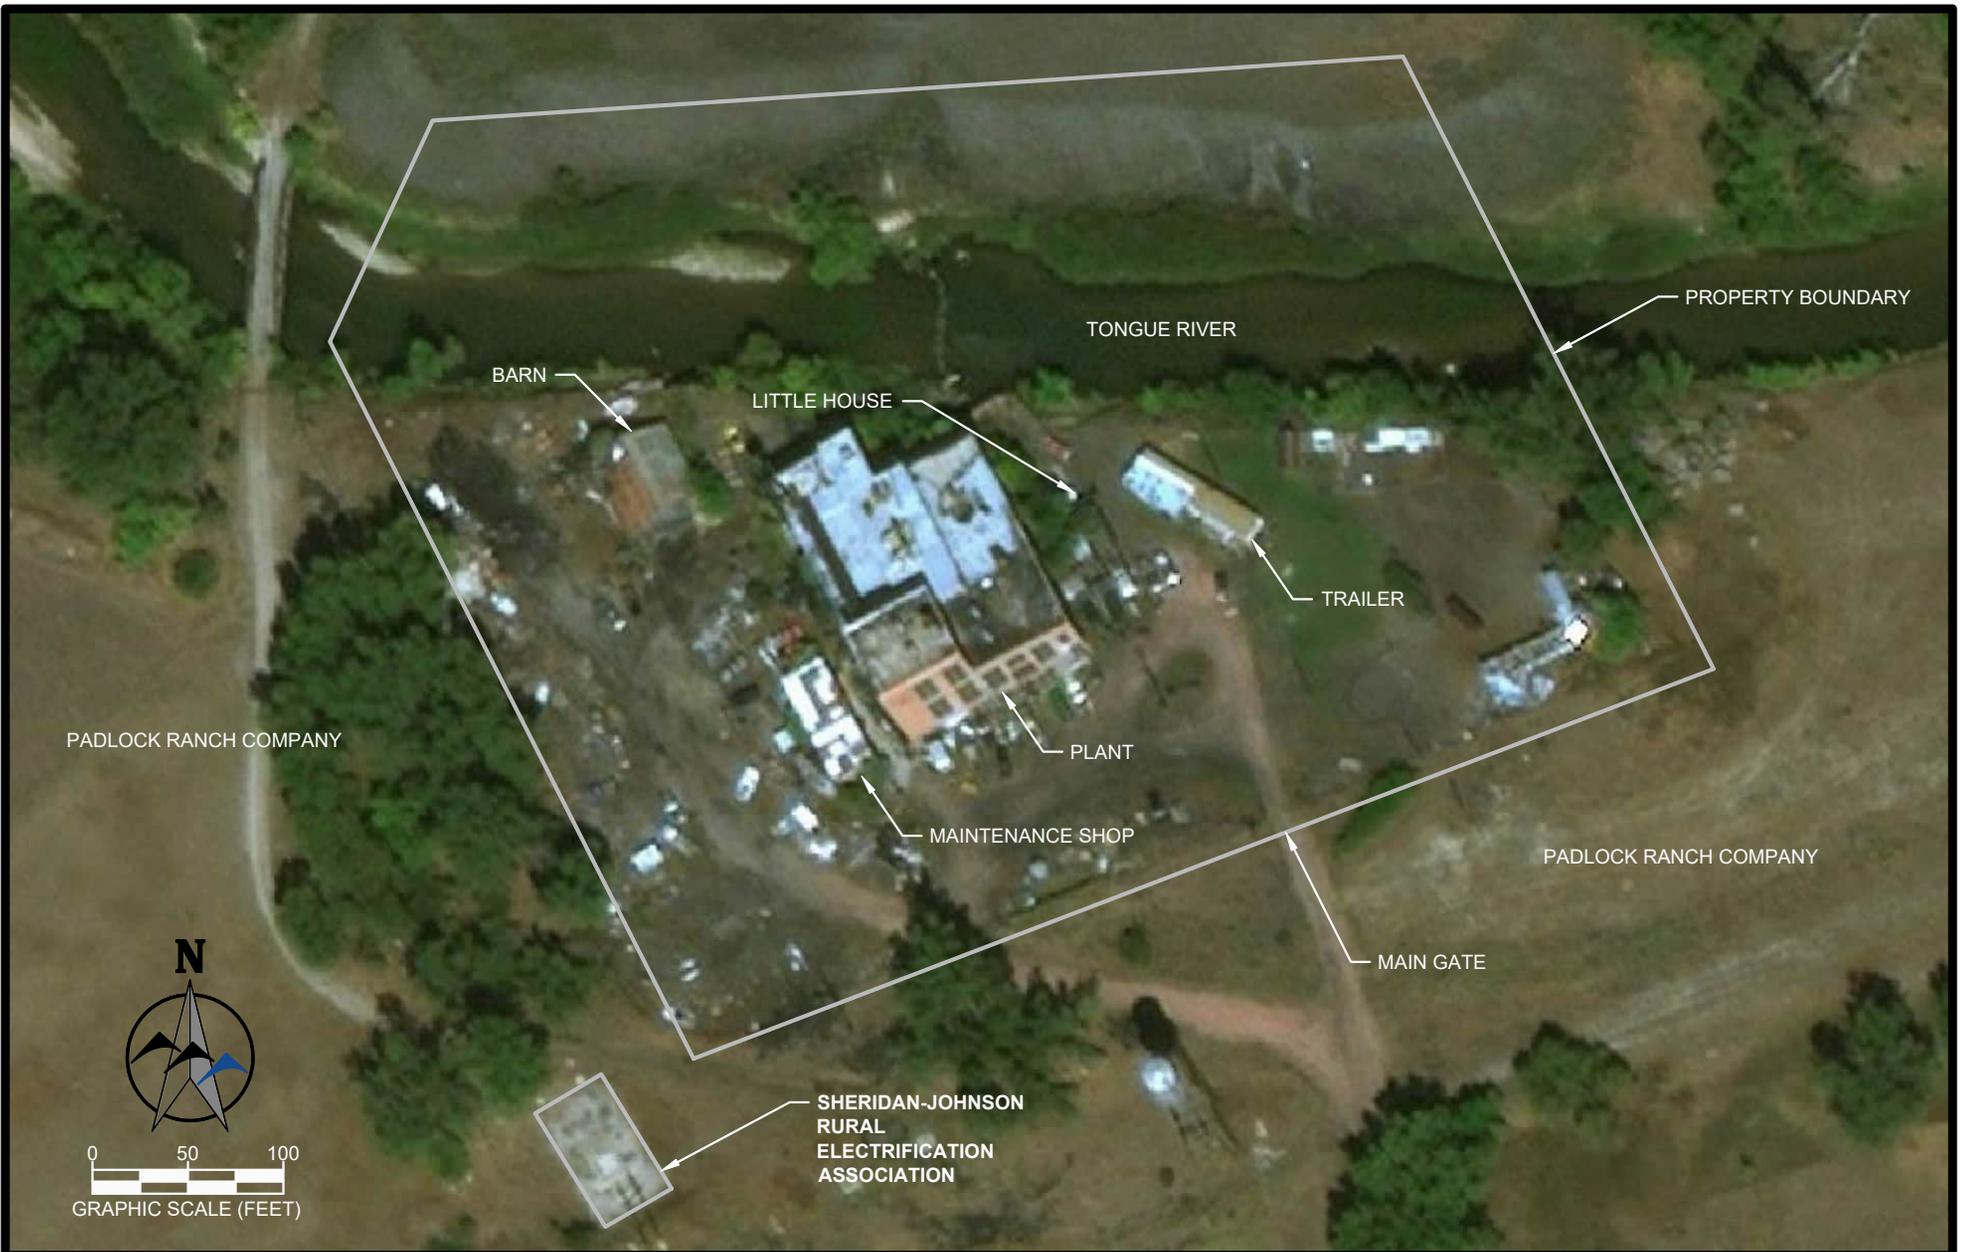
FIGURE 2. CURRENT SITE LAYOUT

IMAGE SOURCE: BING IMAGERY; IMAGE DATE: APPROX. SUMMER 2016

The Site is a 5.8-acre parcel located in Sheridan County near the historical town of Acme, Wyoming. The Site location in relation to Sheridan, Wyoming, is shown on Figure 1. The current Site layout is shown on Figure 2. The Site is located in the North ½ of the Southwest ¼, Section 15 of Township 57 North, Range 84 West, Section 15, (Sheridan County Parcel ID 57841530000333). Adjacent properties are owned by the Padlock Ranch Company. Nearby properties are owned by Black Gold Land Company, Sheridan-Johnson Rural Electrification Association, and the State of Wyoming.
